Safety Notice – Secondary Heat Exchangers

Serious Gas Furnace Issues

Gas Furnaces MODELS AFFECTED: 340A, 340M, 345M, 350A, 350M, 351D, 352A, 352M, 355A, 355B, 355C, 355M 58MCA, MCB, MXA, MXB, MSA, UVB, MVP, MVB, MVC, MTA, MTB 490A, PG9M

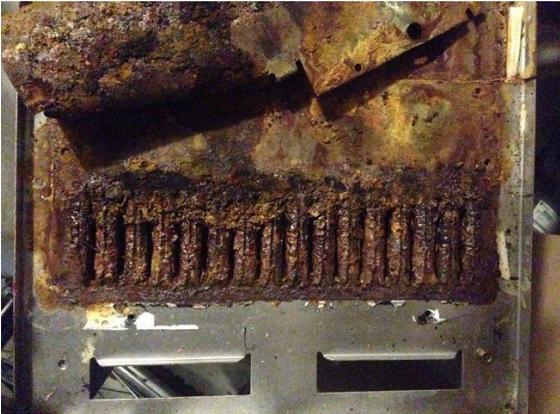
Failed Secondary Cells

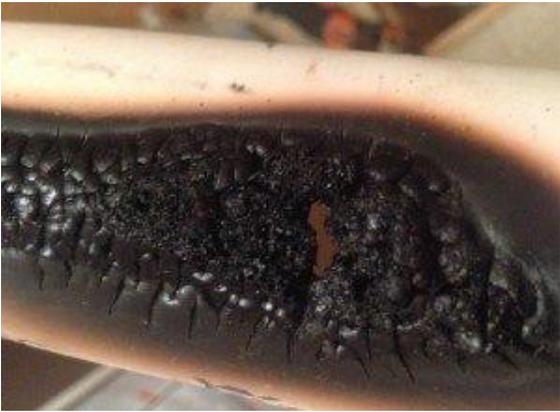
Vent pipe damaged from heat

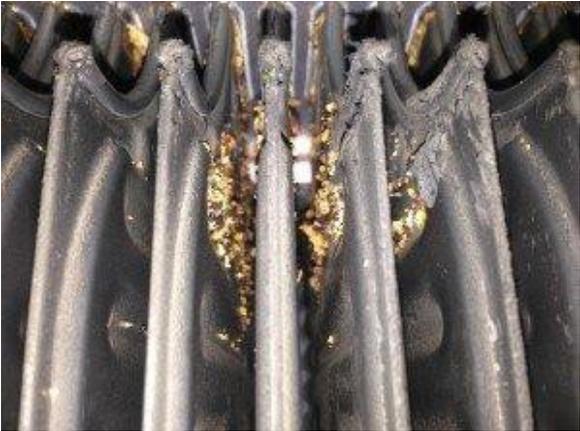
Corrosion buildup on secondary cells
